Manhole Inspection Summary

Manhole # S53II_008MH

Insp Date: **4/17/08 11:13 AM**

Location Address: **Edsion Hwy**

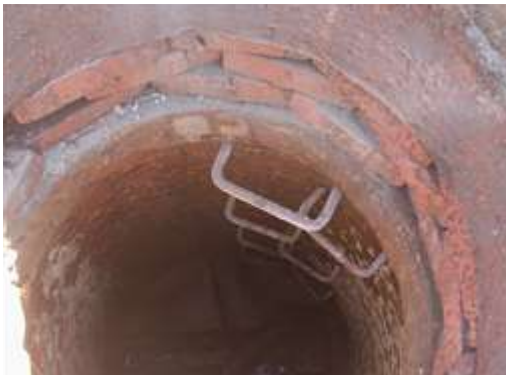
Defect 2

frame leaks

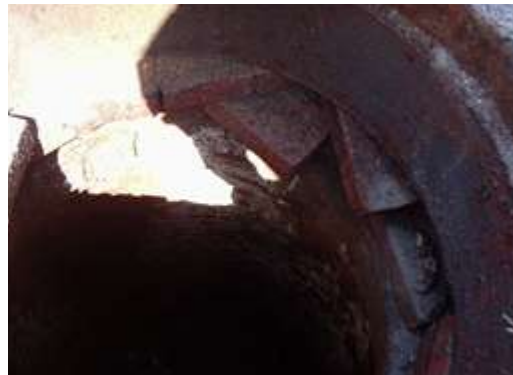
Defect 1

Condition: ☐ Sound ☐ Cracked ☐ Root Intrusion ☒ **Loose Brick** ☐ Deteriorated

Infiltration: ☐ None ☒ **Joint** ☐ Cracks ☐ Mortar ☐ Roots ☐ Wall

loose brick

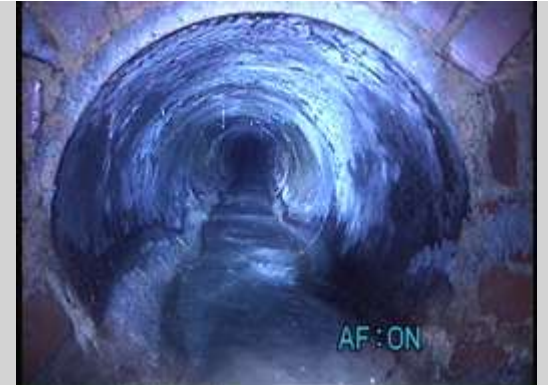
12 O'Clock Outflow

18 in. Circular Gravity Sewer
Pipe Out @ 12 O'Clock

Pipe Height: **16.8** (in.) Rod and Bar (Angled)
Pipe Material: **Clay** ☐ Pipe Lined
Invert Depth: **12.70** (ft.) Flow Characteristics: **Fast**
Deposits: ☒ None ☐ Mud ☐ Sludge ☐ Debris ☐ Grease
Silt Depth: (in.) Deposits Extent:
Infiltration: **None** Pipe Seal Cond: **Sound**

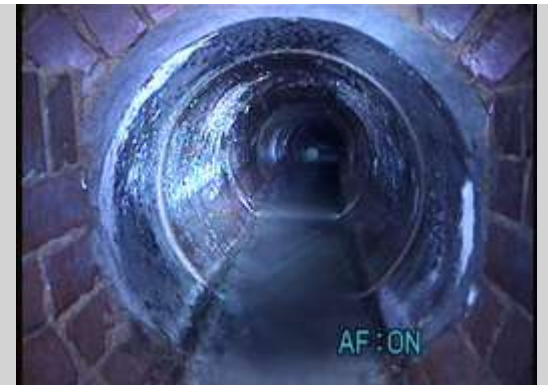
3 O'Clock Inflow

15 in. Circular Gravity Sewer
Pipe In @ 3 O'Clock

Pipe Height: **15.6** (in.) Rod and Bar (Angled)
Pipe Material: **Clay** ☐ Pipe Lined
Invert Depth: **12.70** (ft.) Flow Characteristics: **Fast**
Deposits: ☒ None ☐ Mud ☐ Sludge ☐ Debris ☐ Grease
Silt Depth: (in.) Deposits Extent:
Infiltration: **None** Pipe Seal Cond: **Sound**

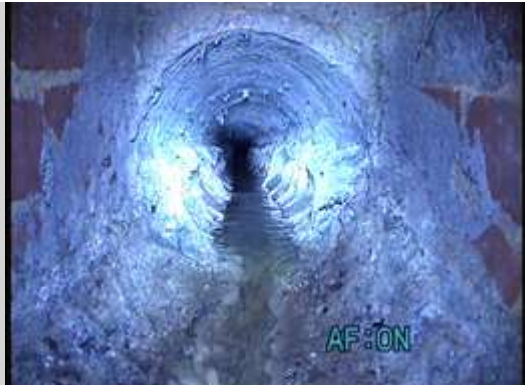
6 O'Clock Inflow

Pipe In @ 6 O'Clock

Pipe Height: **12** (in.) Rod and Bar (Angled)

Infiltration: **None** Pipe Seal Cond: **Sound**

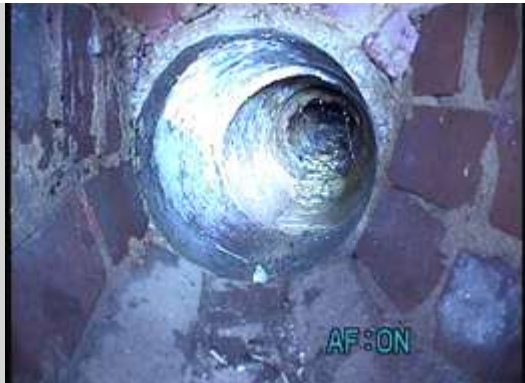
9 O'Clock Inflow

Pipe In @ 9 O'Clock

Pipe Height: **10.8** (in.) Rod and Bar (Angled)

Infiltration: **None** Pipe Seal Cond: **Sound**
